# Delaware Canal Preliminary Stormwater Study

December 2017

## **An Overview**

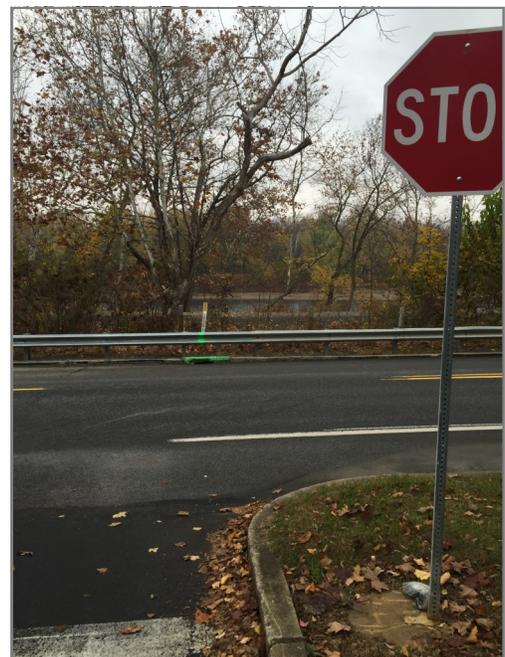
significant sedimentation or erosion damage to the canal. Inlets along PA Route 611 are in poor condition with visible sediment build-up inside the inlet boxes. Sediment deposits on the roadway at the intersection indicate ponding during storm events. Erosion on the canal side of Route 611 indicates that water crosses/floods the road and flows into the canal.

At the northeastern corner of the Highlands Boulevard and PA Route 611 intersection is a large inlet box with a culvert installed on the downstream end that discharges into the canal. The location and size of the inlet box and culvert suggest that the watercourse piped under the private property is conveyed into this system. The canal has visible scouring and erosion damage to the prism bottom and prism wall opposite the culvert. Scouring and erosion damage is generally caused by high velocity discharges during storm events.

*Highlands Boulevard and PA Rt 611 Intersection.*

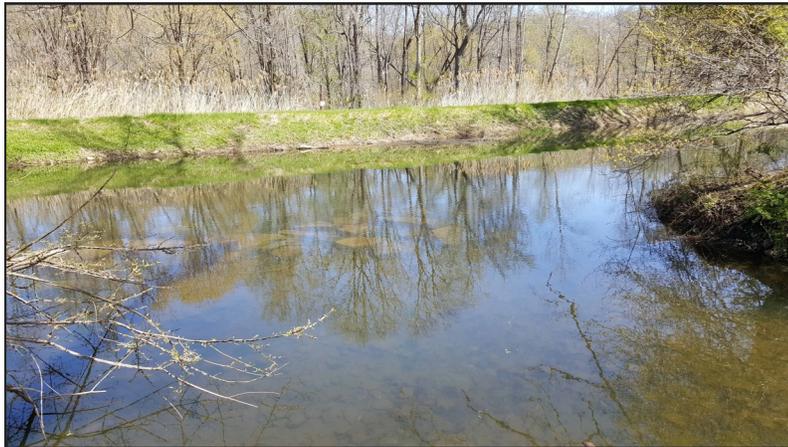
*Settling Basin.*

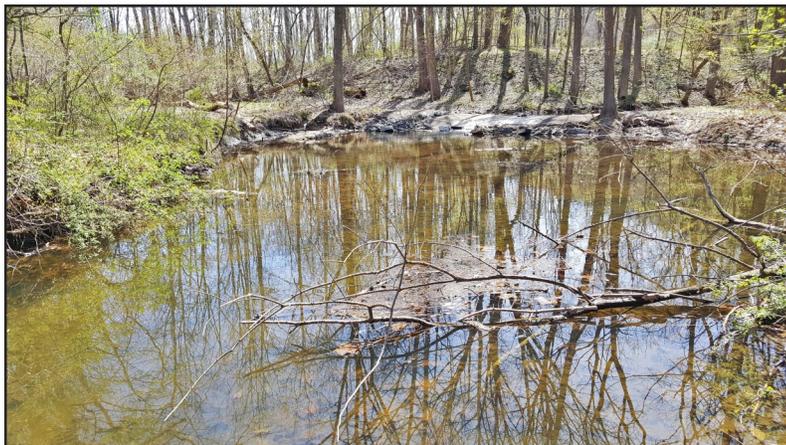
**Observations:** Falls Creek runs down the mountainside and into canal, depositing silt and gravel. The stream bed begins at the top of the mountainside, runs down the slope, and under PA Route 32. The stream drops straight down in some areas causing heavy erosion. The stream has eroded the subsurface of PA Route 32 and has caused portions of the roadway edge to collapse.

*Falls Creek.*

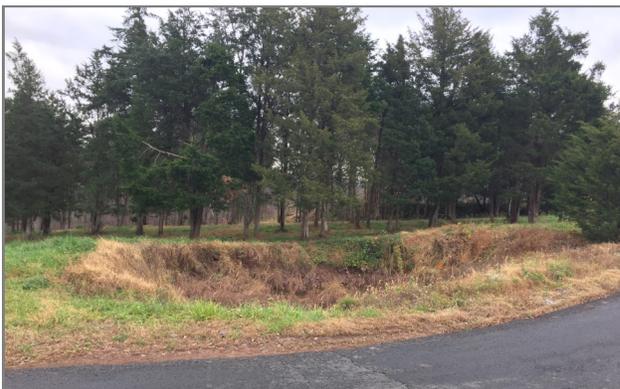
The entrance drive to the site is a steep, paved asphalt road with no evidence of roadside swales. At the top of the entrance drive, north of the building complex, is a small sediment basin. This basin appears to receive a significant amount of run-off from the bare soil crop fields but is significantly undersized. The condition of this basin is poor, with evidence of sediment build-up. There is no inlet or roadside swale to direct water to the basin. Rather, it appears water sheet flows from the crop fields, across the entrance road, and into the sediment basin.

*Undersized sediment basin.*

- Work with landowner of agricultural property to grow field cover species
- Work with landowner of agricultural property to retrofit and expand existing basin
- Add check dams along driveway
- Install upslope swale to direct runoff to basin
- Construct additional sediment basin at the base of the constructed diversion berm
- Prepare a soil conservation plan for agricultural property

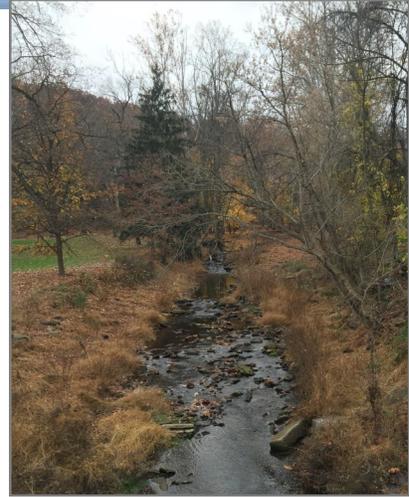
*Paunacussing Creek.*

The aqueduct over the creek is in poor condition with significant structural damage. There is evidence of spalled concrete and severed rebar. The steel beam webs contain portions with up to 100% section loss near the bearings. The bottom flange of the beam has major section loss and is exhibiting knife edging. The remainder of the structural beams have evidence of heavy pitting. The concrete portions of the wall are cracking in the same location which indicates that they are failing and the wall is shifting.

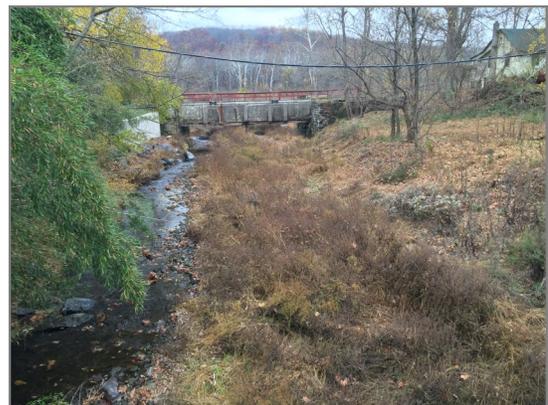
Under the aqueduct, sediment deposits have constricted the waterway to only about four feet of vertical clearance. Within the aqueduct, there were only a couple inches of water during site observation by the SC/HEA team. Water flow into the aqueduct was blocked on the upstream side of the canal. This structure is aging and DCNR is monitoring its condition. Flow is blocked on the upstream side to regulate the water level north of the aqueduct. The towpath on the aqueduct remains open to the public.

*Sediment deposits under aqueduct.*

**DCNR Management Efforts:** The creek bed under the aqueduct and 50 feet upstream and downstream have been excavated three times in the last two years. However, the problem extends well beyond this area into private property upstream. DCNR is currently limited to work within a 50-foot buffer zone around the aqueduct. This 50-foot work limit is set by state and federal agencies including Pennsylvania Department of Environmental Protection and the Army Corps of Engineers. This study recommends that DCNR work with the appropriate jurisdictional agencies toward a solution and work with local landowners to excavate entire area and mitigate sedimentation drop.

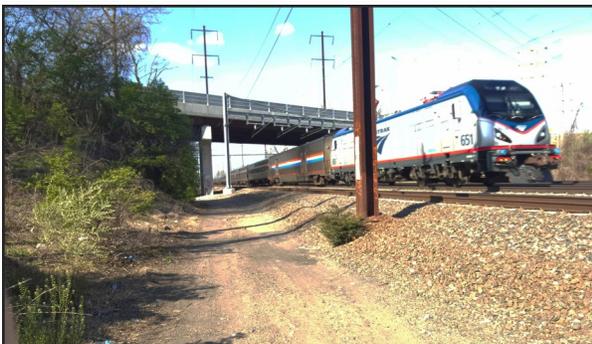
The Conrail Obstruction also creates an unsafe trail condition for towpath users. The towpath is blocked by the Conrail line and rerouted east toward the regional and high speed Amtrak rail. Here the path runs parallel to the tracks without any physical barrier for over 300 feet. This hazard to the safety of trail users needs to be addressed prior to any injuries that may occur along the railroad. A construction contract awarded in 2017 will open up the towpath section of this obstruction, but does not address the water obstruction issues.

*Informal pedestrian/bicycle path along railroad.*

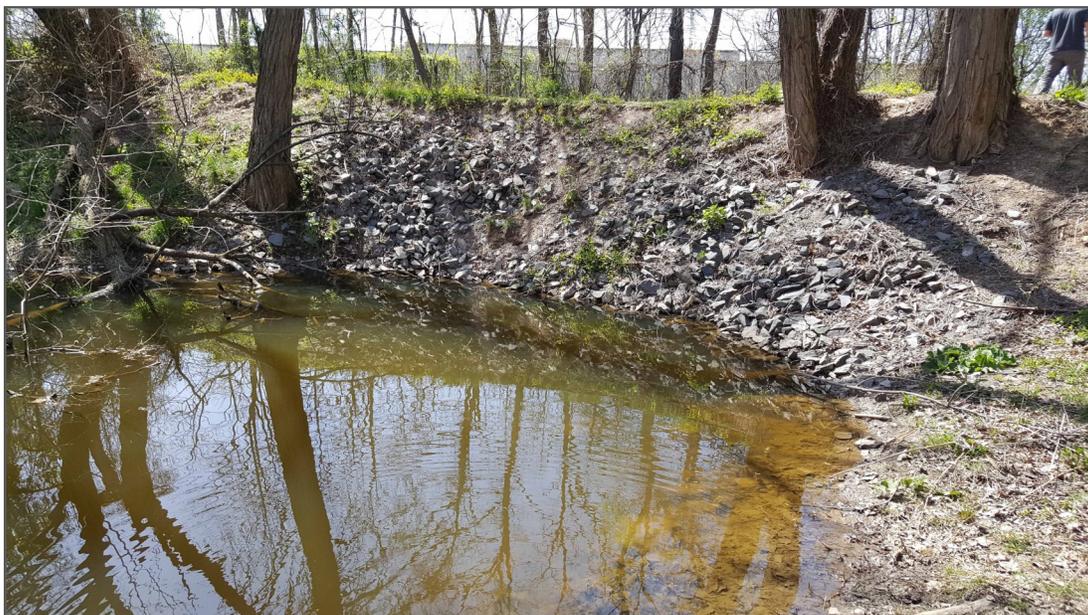
*Ponding adjacent to the canal.*
