# Delaware Canal Preliminary Stormwater Study

December 2017

## **An Overview**

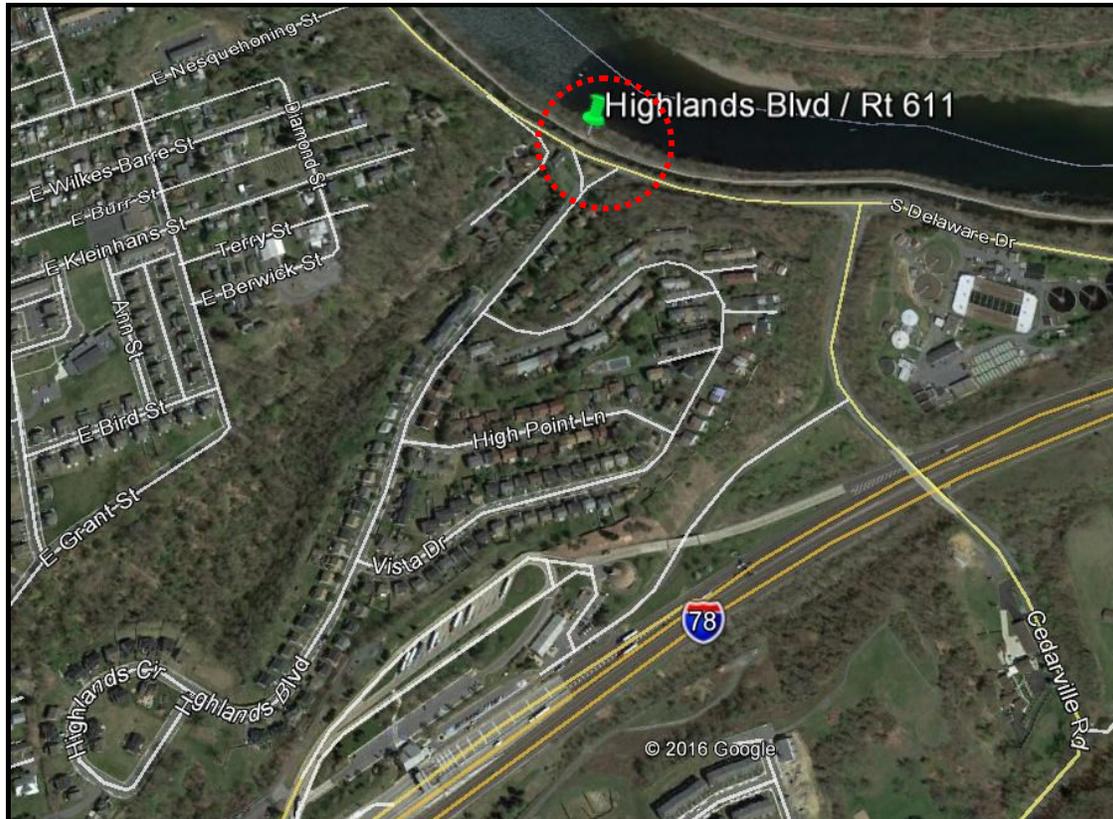
### 2.3.1. Highlands Boulevard and PA Route 611 Intersection

**Impacts to Canal:** Gravel bar deposits across channel and dam up the canal. Velocity of stormwater entering the canal erodes the towpath structure.

**Observations:** The steep slope of Highlands Boulevard directs surface and piped water flow toward PA Route 611. In addition, the roadway appears to have little or no crown, and inlets are spaced over long distances. The result is excess water bypassing existing inlets and collecting at the intersection of Highlands Boulevard and PA Route 611. Water collected in storm inlets along Highlands Boulevard is piped down slope and conveyed perpendicular to the road, onto a private property (tax id: L10SW4D7 3 0310) north of Highlands Boulevard.

significant sedimentation or erosion damage to the canal. Inlets along PA Route 611 are in poor condition with visible sediment build-up inside the inlet boxes. Sediment deposits on the roadway at the intersection indicate ponding during storm events. Erosion on the canal side of Route 611 indicates that water crosses/floods the road and flows into the canal.

At the northeastern corner of the Highlands Boulevard and PA Route 611 intersection is a large inlet box with a culvert installed on the downstream end that discharges into the canal. The location and size of the inlet box and culvert suggest that the watercourse piped under the private property is conveyed into this system. The canal has visible scouring and erosion damage to the prism bottom and prism wall opposite the culvert. Scouring and erosion damage is generally caused by high velocity discharges during storm events.

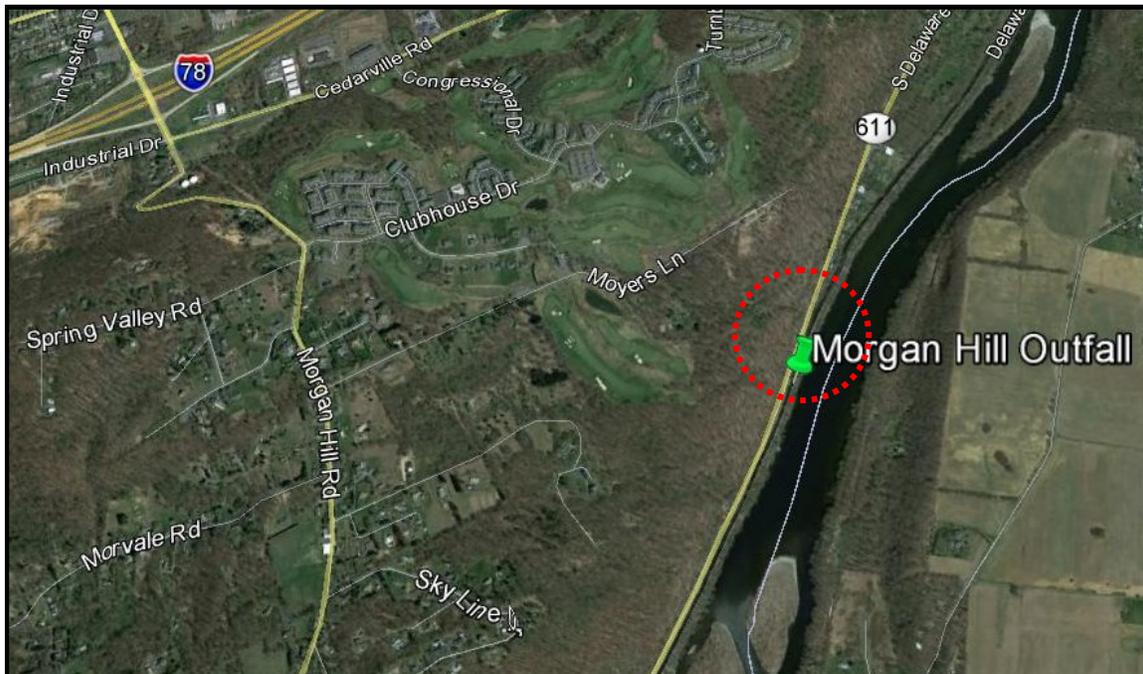
**Impacts to Canal:** Gravel bars extend across the channel, block water flow within the canal. High velocity discharge from culvert during heavy rains causes canal erosion. While at other times, the canal bed is dry.

**Observations:** The recently built private golf course and residential subdivision upland from the canal has drastically increased runoff and sediment discharge. The golf course community covers 330 acres and includes 140 townhomes, 180 condominiums, and an 18-hole golf course.

A deep discharge channel downhill to a roadside swale was observed. DCNR noted high velocity discharge during storm events.

The high velocity of this discharge has caused visible erosion and scouring damage to the canal prism bottom and prism wall opposite the outfall. In an attempt to counter these impacts, concrete was added inside the outfall end of the pipe. This is the only evidence of a control measure to slow the water velocity. A shallow roadside swale exists on the western side of PA Route 611, but is not designed to slow, collect, or hold the discharge volume from the golf course. A recent mudslide from the hillside covered PA Route 611 with several feet of earth.

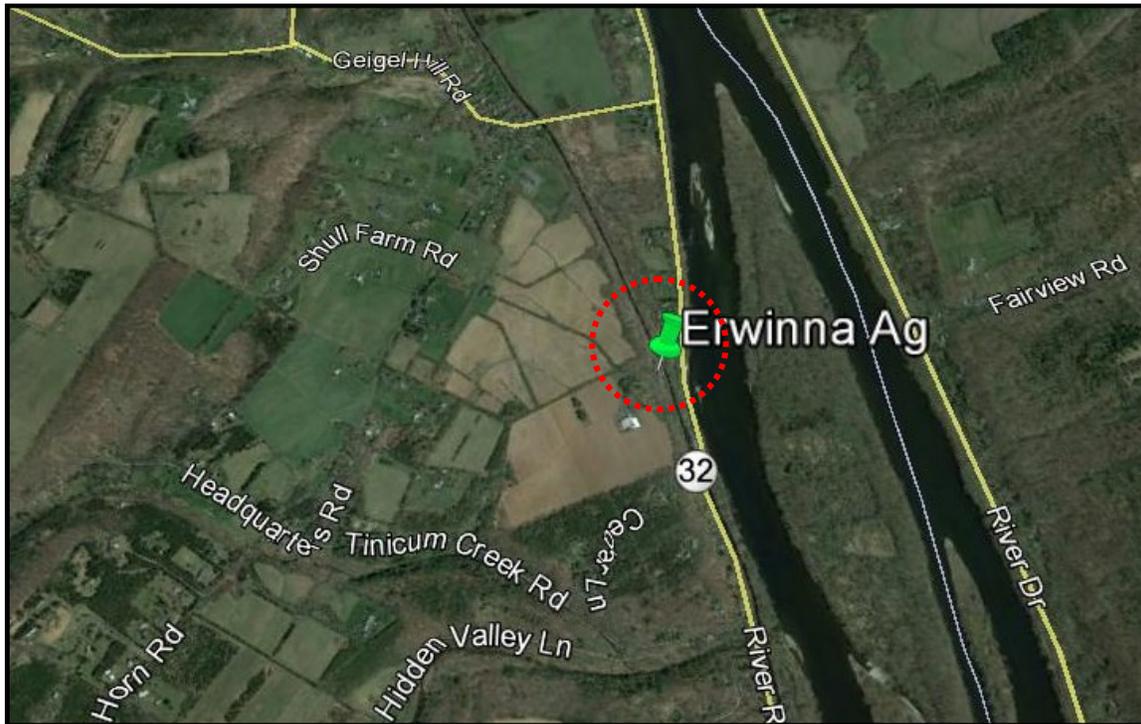
**Impacts to Canal:** Gravel bars and large amounts of sediment accumulate in canal. The stream threatens to erode towpath and canal walls, even with reinforcements in bank.

**Observations:** As evident from aerials and on-site observations, the approximately 40-acre agricultural operation near Erwinna includes a vast area of exposed bare soil. This results in excess sediment loss through run-off from bare soil crop fields. It appears that water run-off from the site is directed toward two water courses in different watersheds. The northeast portion of the site drains directly into the canal. The southwest portion of the site drains toward the Tincum Creek watershed.

The entrance drive to the site is a steep, paved asphalt road with no evidence of roadside swales. At the top of the entrance drive, north of the building complex, is a small sediment basin. This basin appears to receive a significant amount of run-off from the bare soil crop fields but is significantly undersized. The condition of this basin is poor, with evidence of sediment build-up. There is no inlet or roadside swale to direct water to the basin. Rather, it appears water sheet flows from the crop fields, across the entrance road, and into the sediment basin.

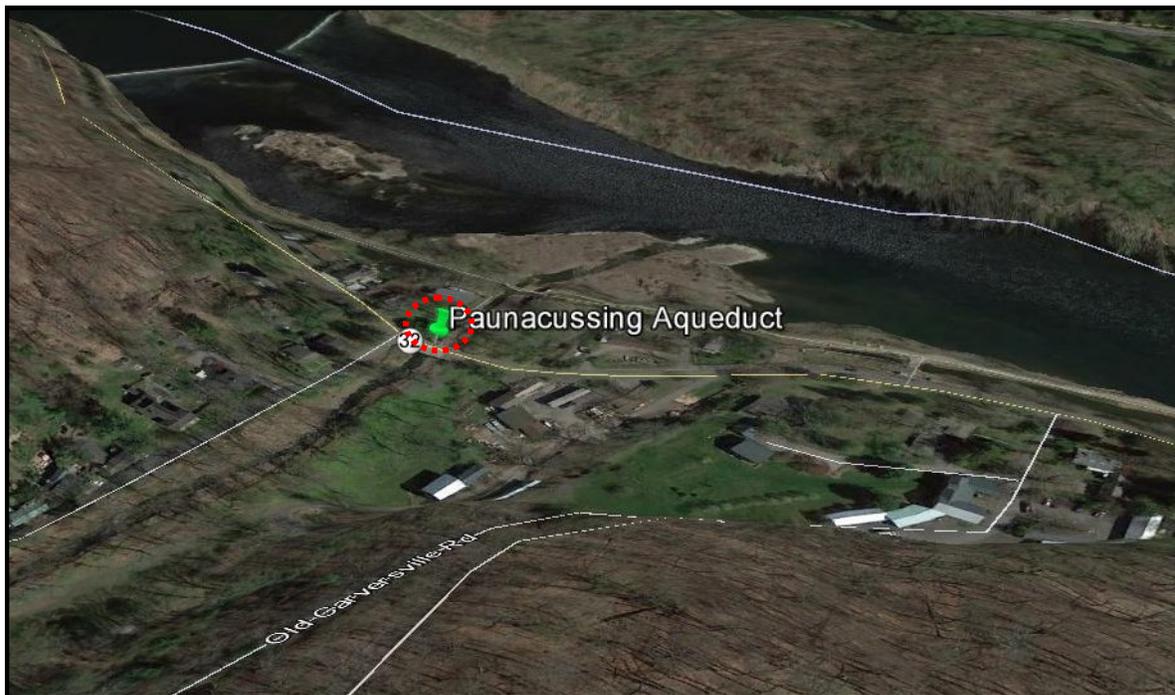
**Impacts to Canal:** Creek deposits and eroded bedrock bars above the confluence of the canal and Delaware River require continual maintenance of rock removal to prevent adversely affecting the Paunacussing aqueduct.

**Observations:** The confluence of the Paunacussing Creek with the Delaware River forms an alluvial delta with sediment deposits from the Paunacussing Creek stretching far out into the Delaware River. The creation of this alluvial delta is twofold, caused by conditions on the Delaware River and the Paunacussing Creek.

On the Delaware River, just upstream of the Paunacussing Creek, is a wing dam that directs the river channel to the eastern side of the Delaware River. This causes slower flow in the Delaware where the Paunacussing Creek converges, creating an eddy where Delaware River sediments are deposited.

The other cause of the alluvial delta is the slope of the Paunacussing Creek in its steep upper watershed areas causing streambank erosion. Near the Delaware River confluence, the topography is significantly flatter, which allows the water velocity to slow and eroded sediments to deposit under the Delaware Canal aqueduct and out into the Delaware River.

Under the aqueduct, sediment deposits have constricted the waterway to only about four feet of vertical clearance. Within the aqueduct, there were only a couple inches of water during site observation by the SC/HEA team. Water flow into the aqueduct was blocked on the upstream side of the canal. This structure is aging and DCNR is monitoring its condition. Flow is blocked on the upstream side to regulate the water level north of the aqueduct. The towpath on the aqueduct remains open to the public.

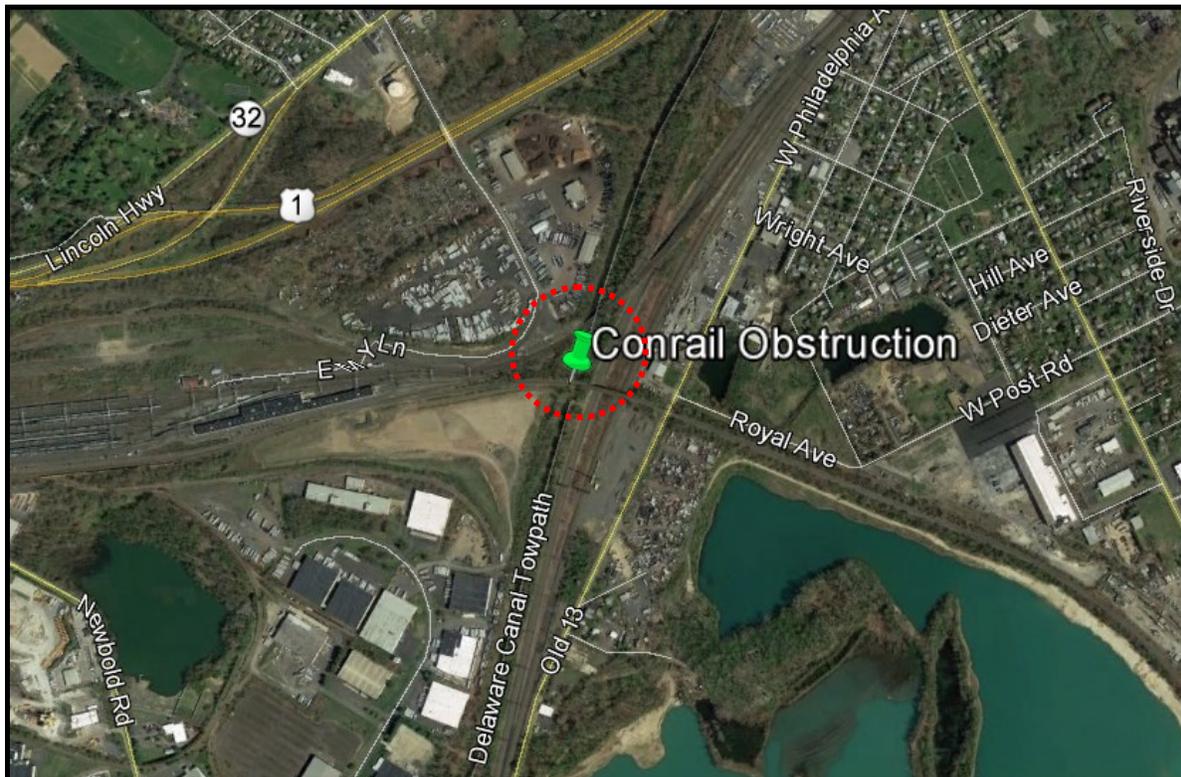
**Impacts to the Canal:** Physical obstruction in the canal that causes flooding upstream into Morrisville Borough.

**Observations:** At the Conrail Obstruction location, an elevated railroad spur embankment was built by filling in the Delaware Canal waterway and towpath directly south of the Morrisville Borough-Falls Township line. The undersized culvert installed below this obstruction at the time the canal was filled in prevents the free flow of water in the canal to move southward. A comprehensive study of the canal in Morrisville, to include design of the Borough stormwater system, adequate overflow structures, and the design of the flood protection levee is needed to determine system hydraulics.

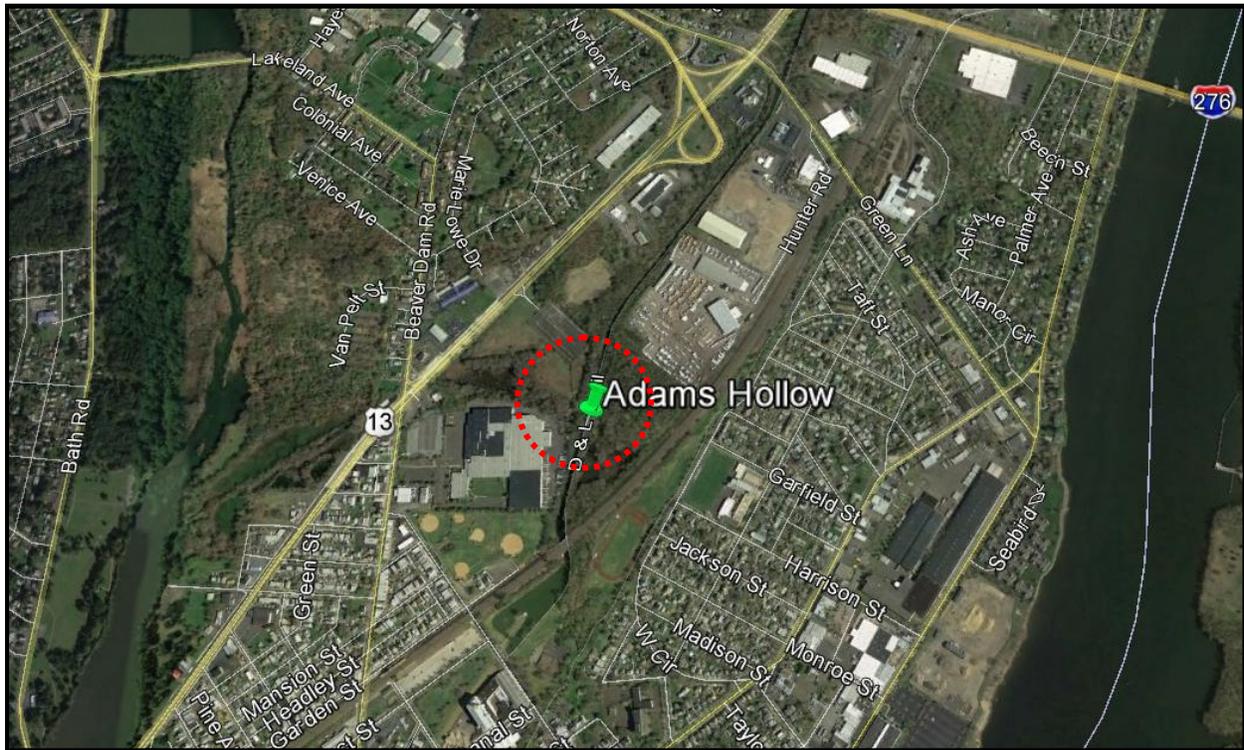
**Impacts to Canal:** Sediment deposits in culvert.

**Observations:** The southern section of the canal, primarily south of Yardley Borough, is heavily developed with more impervious surfaces than many other areas to the north. The topography is also flat, which means the canal is built up from ground level in many instances. Near the location where Adams Hollow crosses under the canal, the water level in the canal is higher than the adjacent parking lot and finished floor elevation of the adjacent Hubbell lighting facility, and poses an issue if there were ever a breach in the canal prism wall. Current evidence of erosion of the prism wall suggests that additional structural support may be needed on the upstream side.
